INFRARED INSPECTION REPORT

February 13, 2015

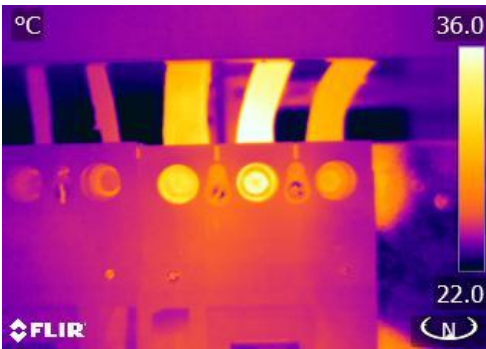
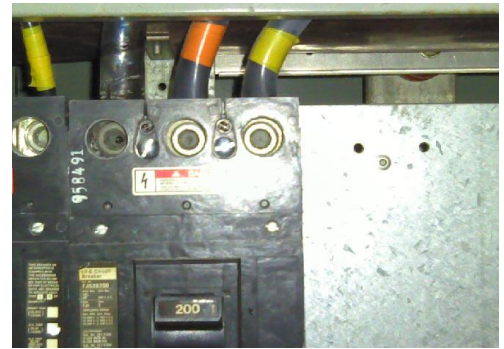
Left Image #: IR_0111	Camera/Lens: T420/25mm	Right Image #: DC_0112
------------------------------	------------------------	-------------------------------

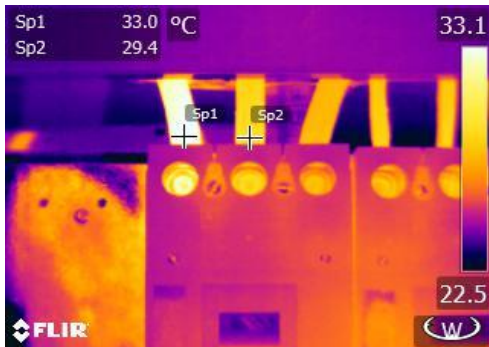
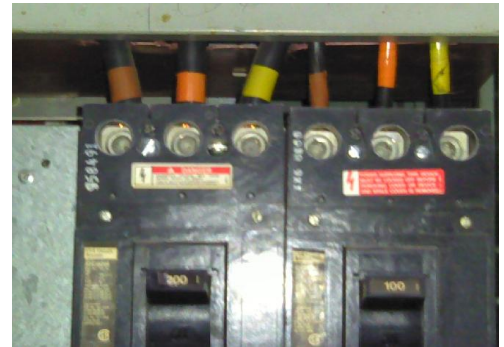
Left Image #: IR_0119	Camera/Lens: T420/25mm	Right Image #: DC_0120
------------------------------	------------------------	-------------------------------

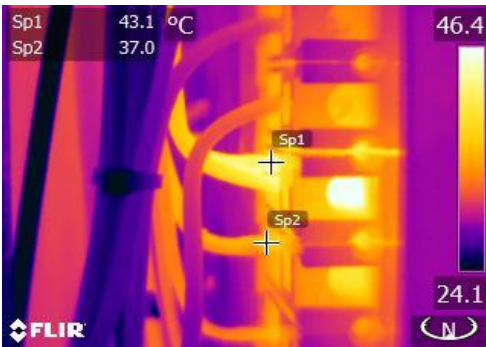
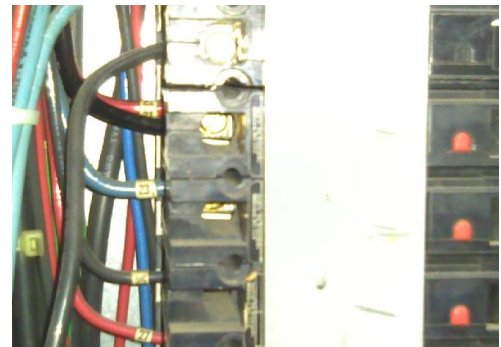
Left Image #: IR_0129	Camera/Lens: T420/25mm	Right Image #: DC_0130
------------------------------	------------------------	-------------------------------

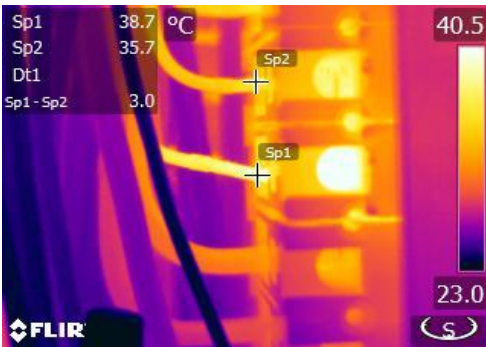
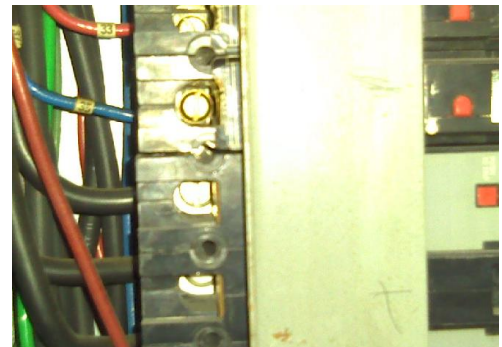
Left Image #: IR_0135	Camera/Lens: T420/25mm	Right Image #: DC_0136
------------------------------	------------------------	-------------------------------

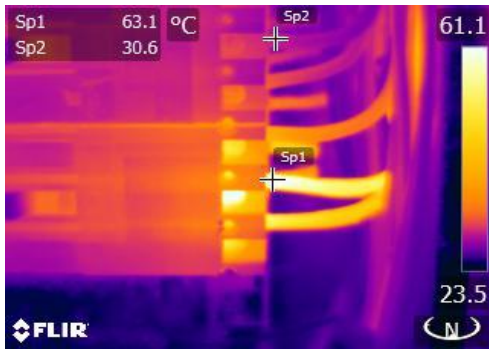
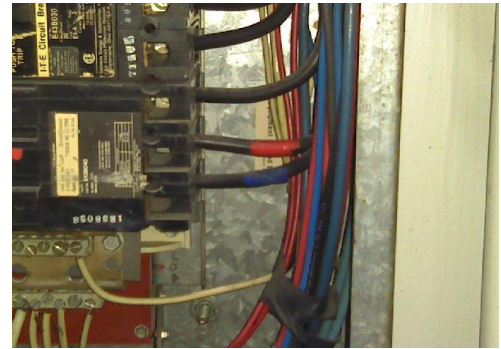
Left Image #: IR_0143	Camera/Lens: T420/25mm	Right Image #: DC_0144
------------------------------	------------------------	-------------------------------

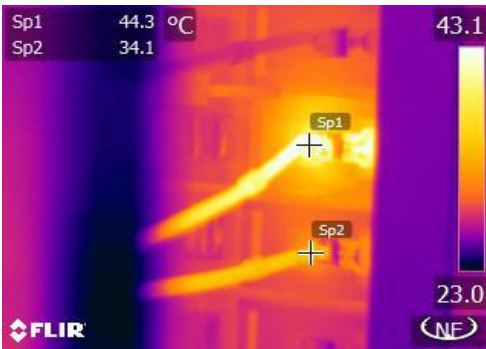
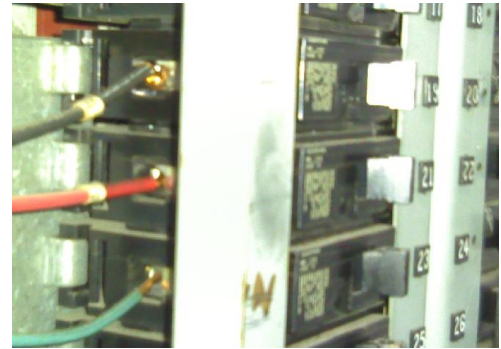
Left Image #: IR_0147	Camera/Lens: T420/25mm	Right Image #: DC_0148
------------------------------	------------------------	-------------------------------

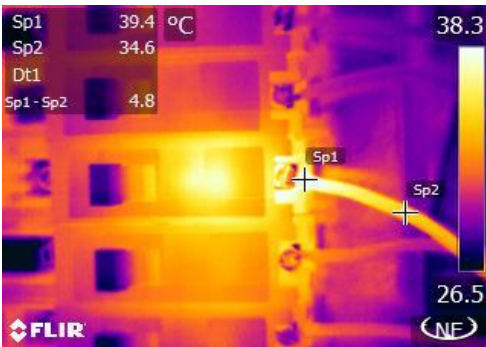
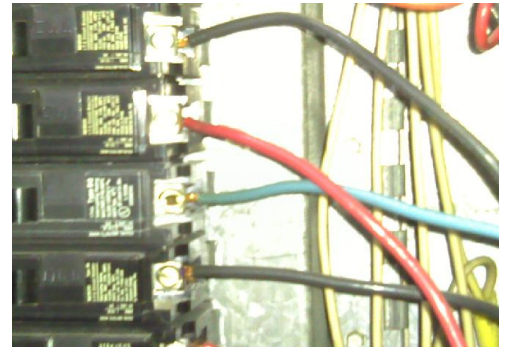
Left Image #: IR_0153	Camera/Lens: T420/25mm	Right Image #: DC_0154
------------------------------	------------------------	-------------------------------

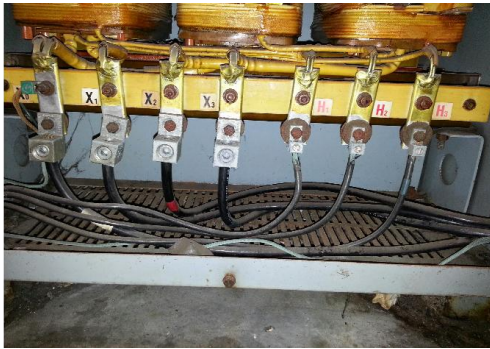
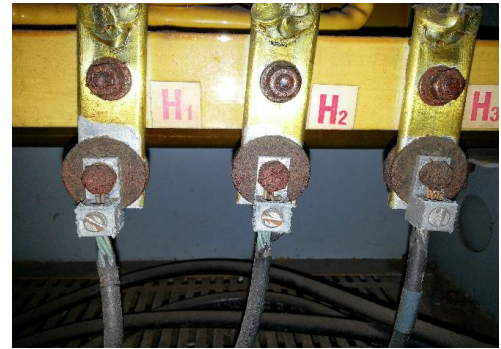
Left Image #: 84420	Camera/Lens: T420/25mm	Right Image #: 84425
----------------------------	------------------------	-----------------------------

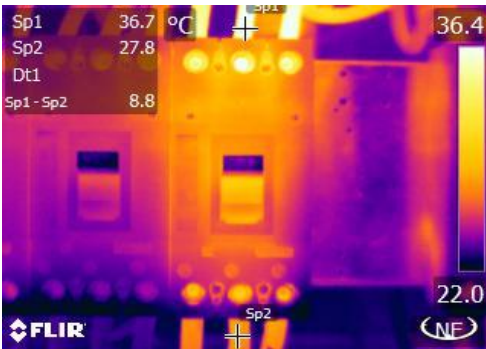
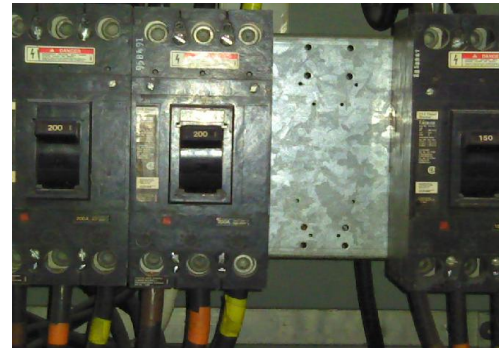
Left Image #: IR_0207	Camera/Lens: T420/25mm	Right Image #: DC_0208
------------------------------	------------------------	-------------------------------

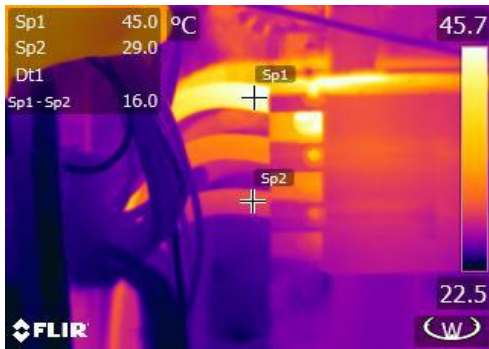
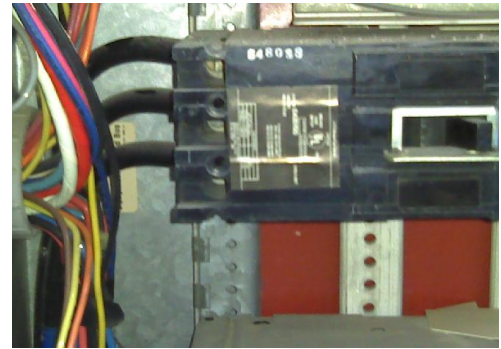
Left Image #: IR_0219	Camera/Lens: T420/25mm	Right Image #: DC_0220
------------------------------	------------------------	-------------------------------
